Accrably Rotary Drive Shaft – Failure Modes and Effects Assessment

Case study

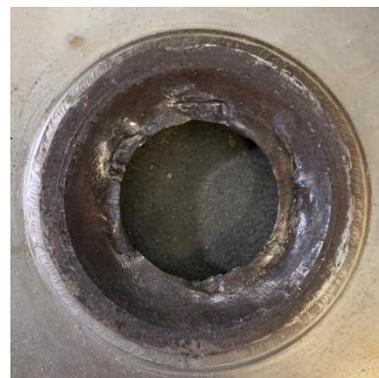
The shaft failed after 5 years of operation (~12.5 million cycles), with the failure surface axisymmetric and different failure modes apparent from the shape.

Figure 2 Failure surface of the shaft

There was evidence of a crack of ~3 mm depth and the part had been post-weld heat treated. As a result, the failure modes considered were:

The failure modes and effects assessment demonstrated that the revised design of creating the shaft from a single billet of material would result in the design code allowable stresses being well in excess of operational stresses and the other noted failure modes not being of concern in future operation. In addition, the design recommendation of increasing the shoulder radius in the region of the previous failure from 0.5 mm to 2 mm would result in an increase in fatigue life by a factor of 80.

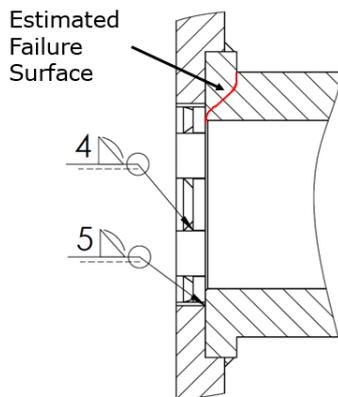
As the failure surface was axisymmetric, it was judged that the principal loading influence must also be axisymmetric. Therefore bending was not considered a significant mode of loading.

Figure 3 Estimated through wall direction of failure surface

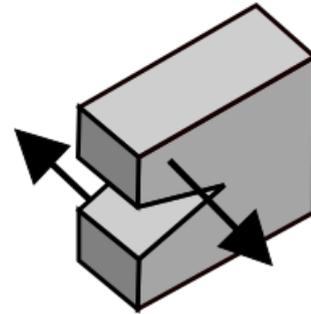
For the fracture assessment, the type of crack was deemed a mode III crack initiating from torsional loading. The crack depth was assumed at ~ 3 mm and to be fully circumferential. The stress intensity factor (SIF) at the crack tip was calculated and evaluated against the material fracture toughness to determine proximity to fracture.

Figure 4 Mode III crack
