Accrably Rotary Drive Shaft – Failure Modes and Effects Assessment

Case study

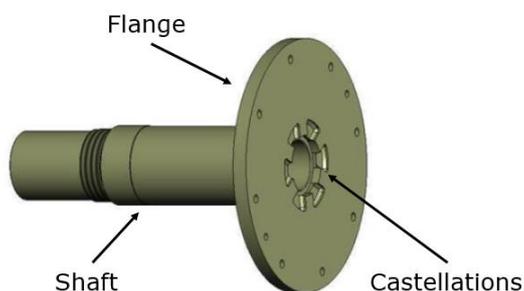
The rotary drive shaft was initially manufactured in two separate pieces, which were welded together making use of castellations on the shaft that were inserted into recesses on the flange.

Figure 1 3D model of the rotary shaft assembly

The failure modes and effects assessment demonstrated that the revised design of creating the shaft from a single billet of material would result in the design code allowable stresses being well in excess of operational stresses and the other noted failure modes not being of concern in future operation. In addition, the design recommendation of increasing the shoulder radius in the region of the previous failure from 0.5 mm to 2 mm would result in an increase in fatigue life by a factor of 80.
