Steel Restraint for Boiler Recovery

Case study

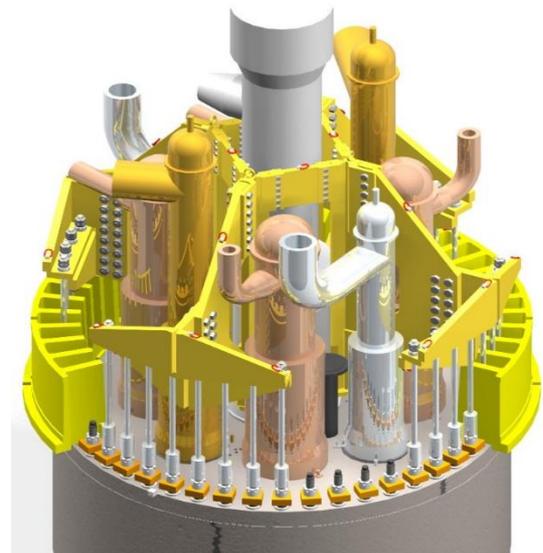
Figure 1 The ESR and primary studs (top); the ESR fitted to a BCU (bottom)

The ESR was designed to be fitted to the upper surface of the BCU and constrained by the BCU primary studs. The function of the structure is to resist the loading from normal operating and fault conditions associated with the BCU assuming no residual pre-stress and that the existing BCU is cracked and, hence, the up-thrust pressure loading acting on the BCU is transferred to the new restraint structure.
